## **Incident Involving 30-Ah Li-ion Cell at NASA Glenn Research Center:**

# Incident Involving 30-Ah Li-ion Cell at NASA Glenn Research Center

William R. Bennett

# Incident Summary

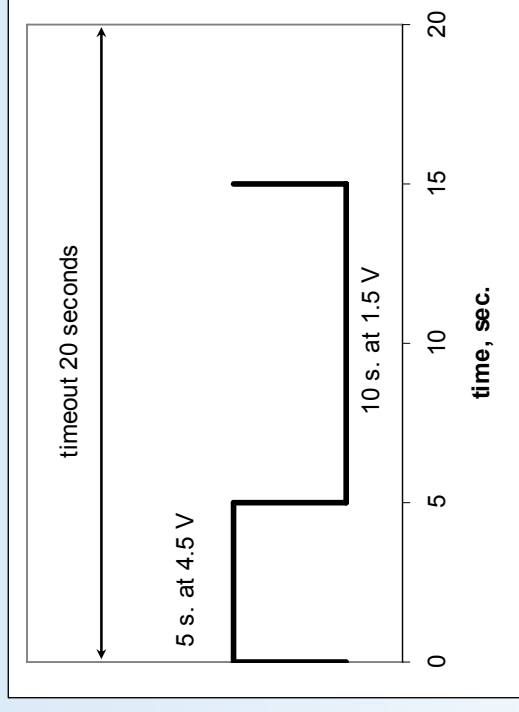
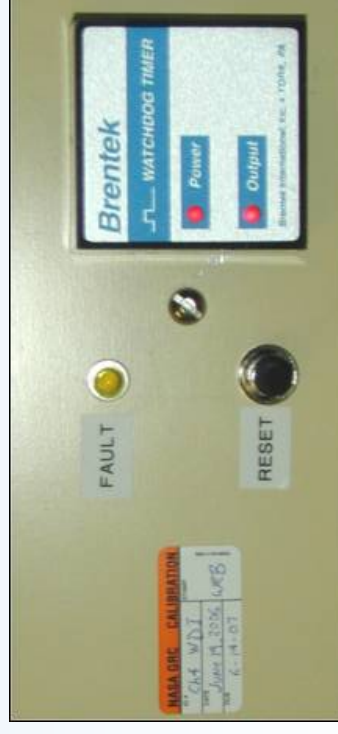
## Features:

- Loss of cyclor control is detected within 20-seconds.
- Requires user intervention to restart system.
- Power loss to timer circuit or PC also shuts down cyclor.
